TECHNICAL REPORT HL-80-12

UTILIZATION OF FILTER FABRIC FOR STREAMBANK PROTECTION APPLICATIONS

Malcolm P. Keown, Elba A. Dardeau, Jr.

July 1980
Final Report

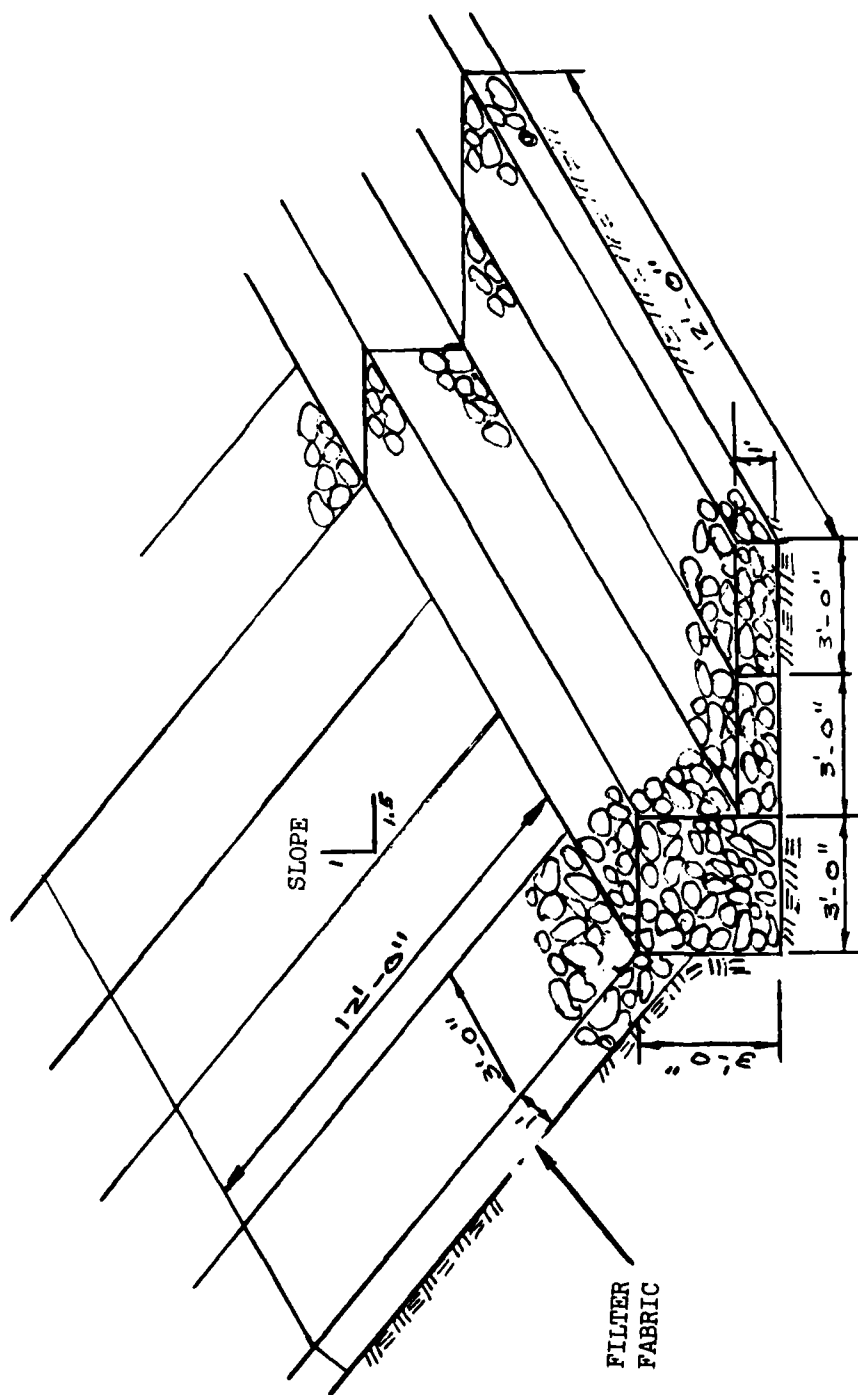
Figure 50. Typical cross section of revetment placed on Little Rockfish Creek, Hope Mills, N. C. (adapted from Little Rockfish Creek, Hope Mills, N. C., Slope Protection, Cross Sections, Drawing No. RC 102-02-28, Sheet 2 of 2, SAW, 19 Sep 1975)

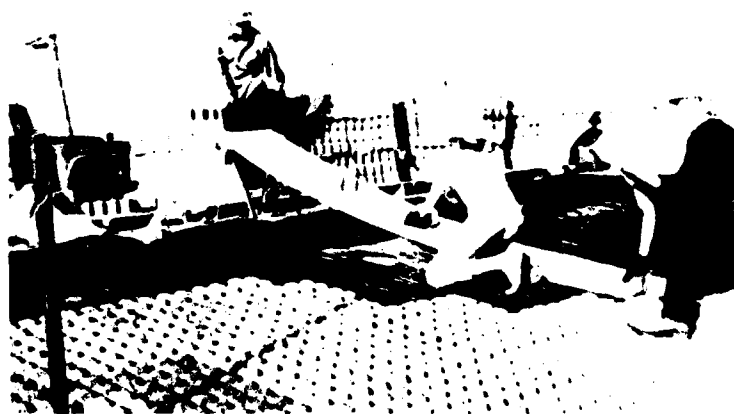
82. In the 1500 ft of the Morameal Revetment designated as Section C, precast cellular blocks (Gobi Blocks, manufactured by ERCO Systems, Inc., of New Orleans, Louisiana) were placed (Figure 55) on Poly-Filter X filter fabric (manufactured by Carthage Mills of Cincinnati, Ohio) to an elevation of 140 ft (May-August 1975). Figure 56 shows the block dimensions, and Figure 57 is a typical cross-sectional drawing of block placement. The Gobi Blocks were hand-placed on the filter fabric and butted together for continuous coverage. During the installation, heavy rains and rising river stages hampered work. In

Figure 55. Typical hand-placement procedure used for assembly of precast cellular block section of Morameal Revetment, La. (1975) (photograph courtesy of ERCO Systems, Inc.)

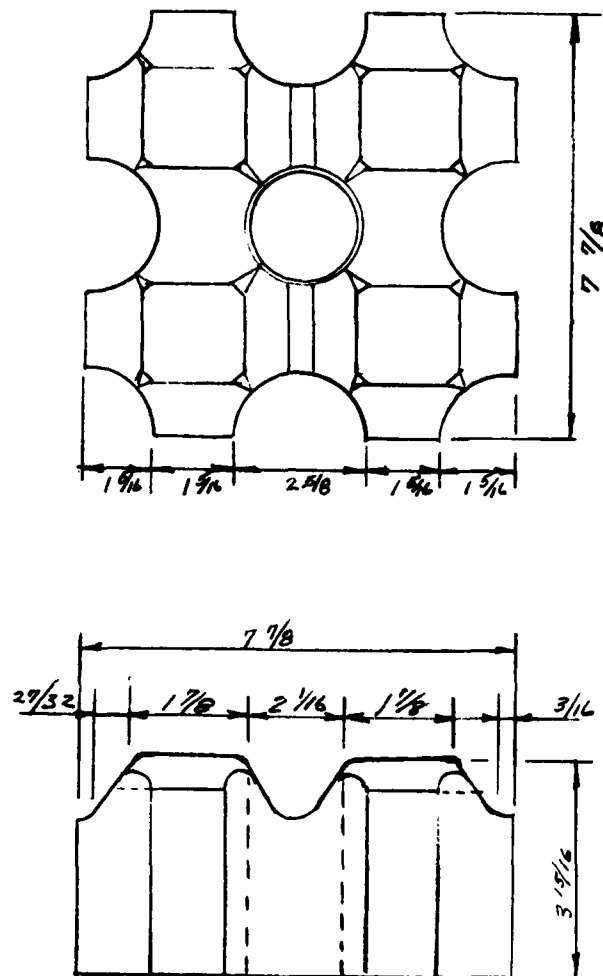
Figure 56. Dimensions of cellular concrete blocks used in construction of Morameal Revetment (Source: "Red River, Morameal, Bossier Parish, Louisiana, Experimental Revetment Item R-257.0-L (1967 Mileage), Sections and Profile", File No. K-108-26744, Drawing 6 of 8, LMN, April 1974)

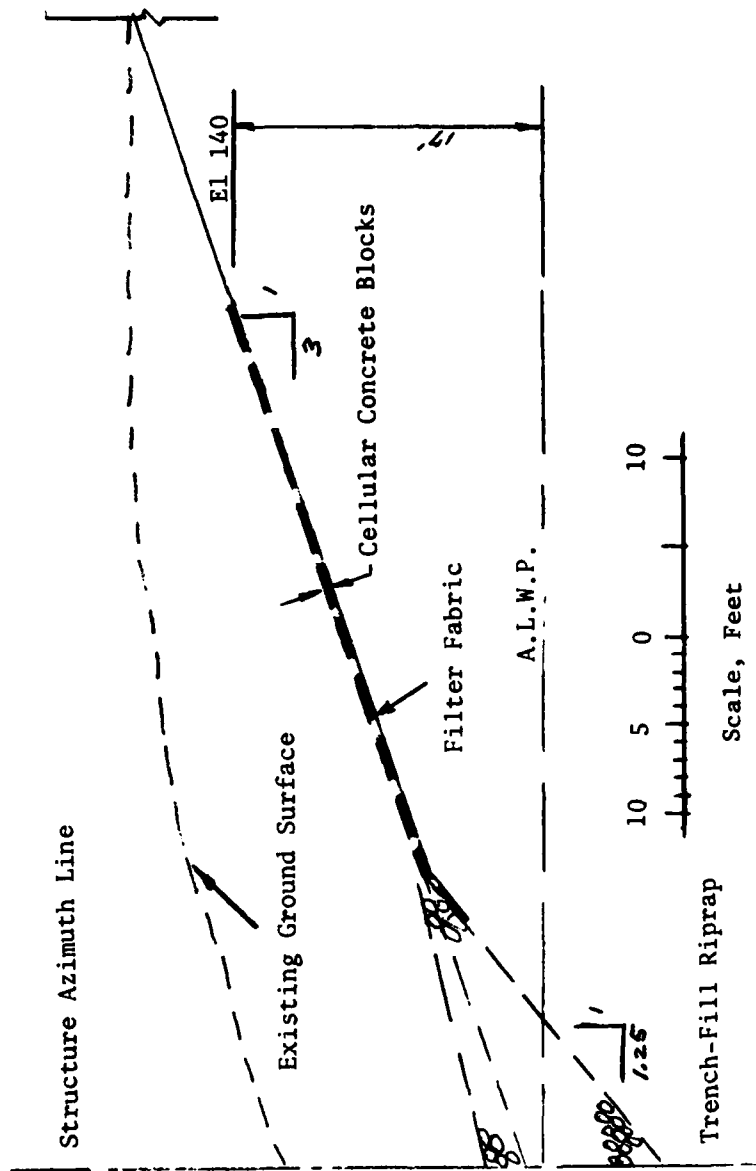
Figure 57. Typical cross section showing placement of precast cellular blocks at Morameal Revetment. Adapted from "Red River, Morameal, Bossier Parish, Louisiana, Experimental Revetment Item R-257.0-L (1967 Mileage), Sections and Profile," File No. K-108-26744, Drawing 6 of 8, LMN, April 1974

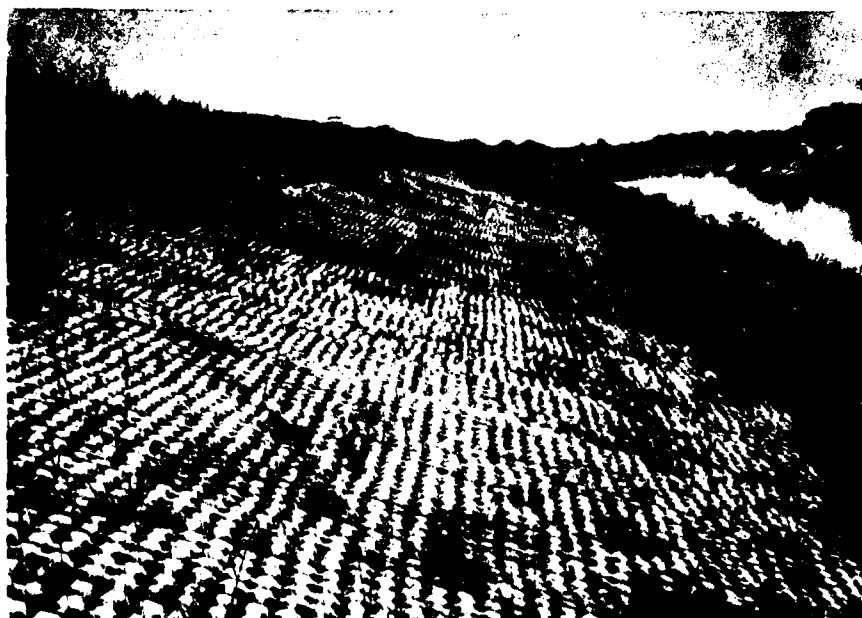
Figure 58. General downstream view of cellular block section of Morameal Revetment, La. (9 May 1978)

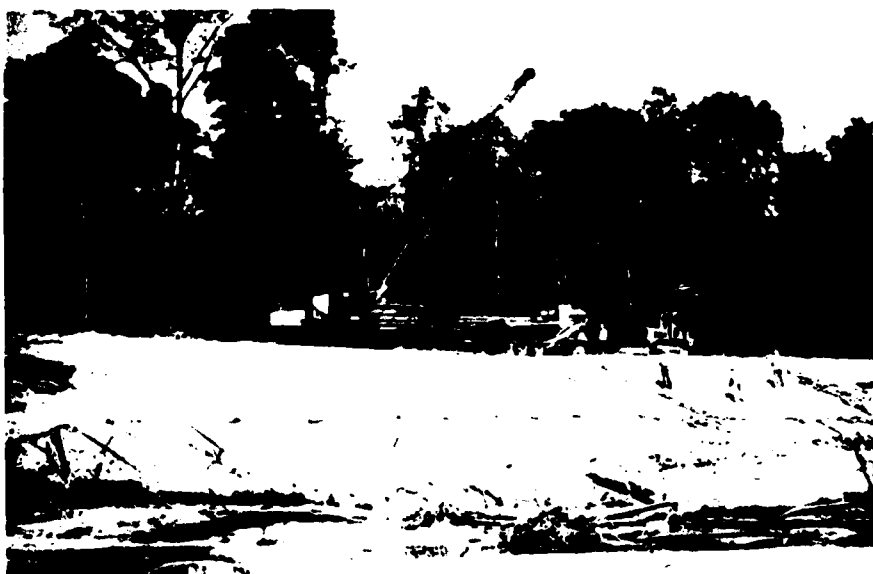
Figure 65. Gobimats being placed on left bank of Tangipahoa River upstream from pipeline crossing near Independence, La. (April 1978) (photograph courtesy of ERCO Systems, Inc.)
